**TARGETED BROWNFIELDS ASSESSMENT REPORT
ENVIRONMENTAL SITE ASSESSMENT PHASE II (ESA II)
FOR THE
LANCASTER AVENUE SITE
LANCASTER AVENUE, PHILADELPHIA, PENNSYLVANIA**

U.S. Environmental Protection Agency
1650 Arch Street
Philadelphia, PA 19103

Tetra Tech EM Inc.
7 Creek Parkway, Suite 700
Boothwyn, PA 19061

May 3, 2006

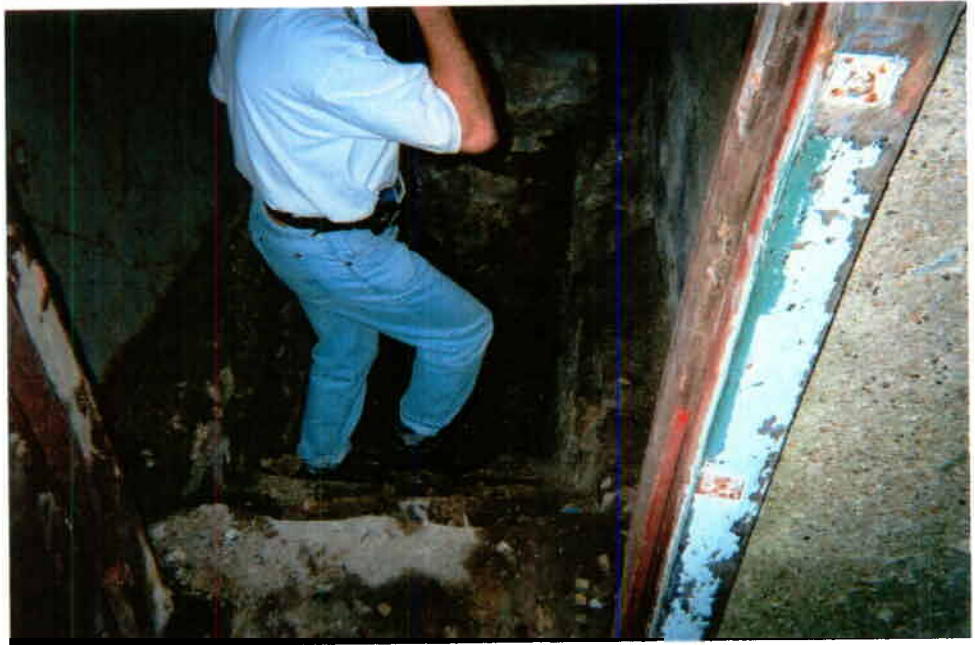
Description: Photograph taken standing at Lancaster Avenue behind the Joe Giordano's Garden Groceries.

Entrance to the basement was very dark, dirty, and with unstable steps.

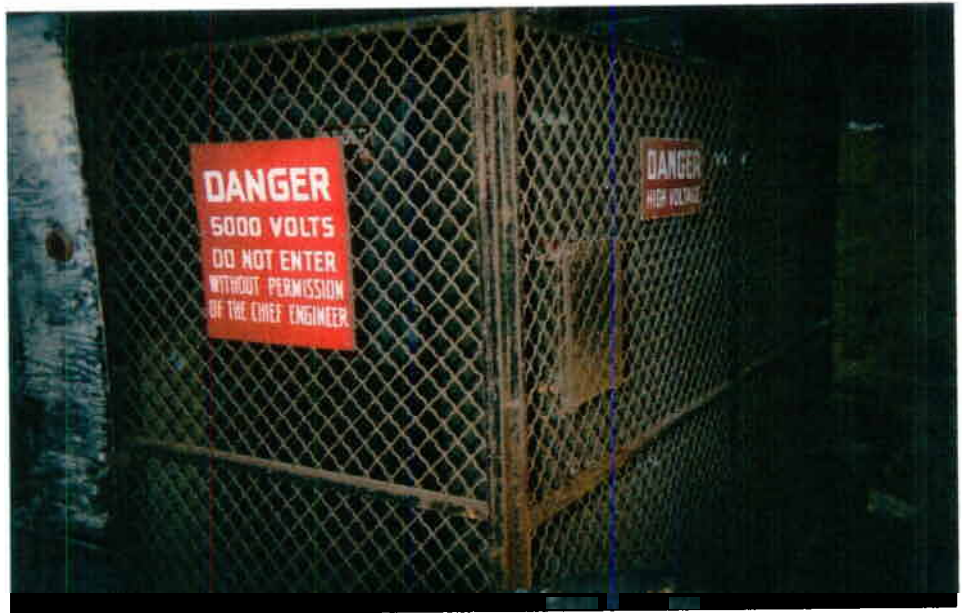
Photograph 6

Orientation: Photograph taken in the basement looking from west to east.

Description:

Caged transformer area is visible. Three containers, each 4 feet high, 1.5 feet wide, and 2 feet deep and marked as 'distribution transformer,' were located inside the fenced area in the basement. Samples LA/SS-05,06,07, and 08 were collected from the transformer area.

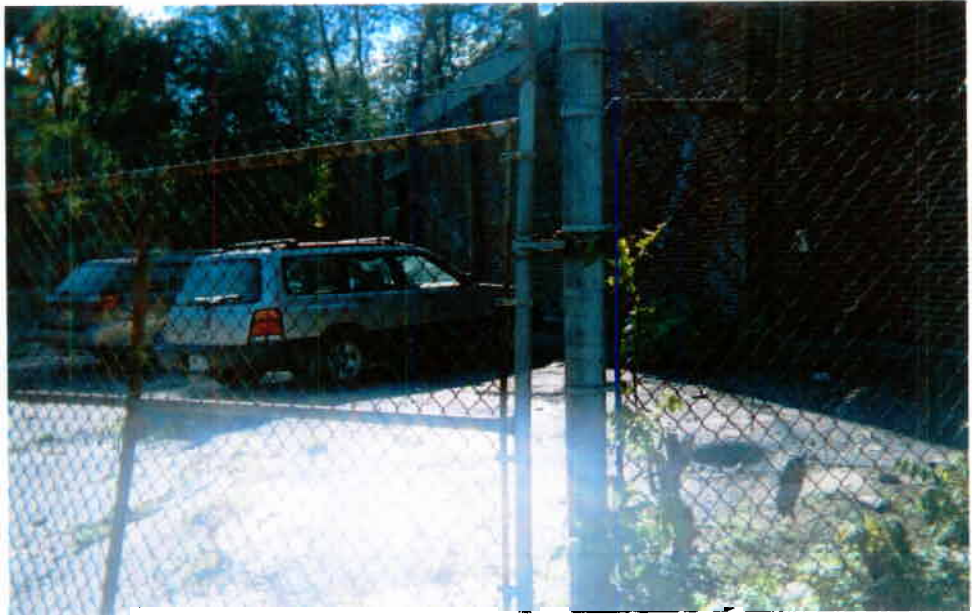
Orientation: View from main entrance to the site on Lancaster Avenue.

Description: One-and-a-half story red brick warehouse is visible on the right side of the photograph.

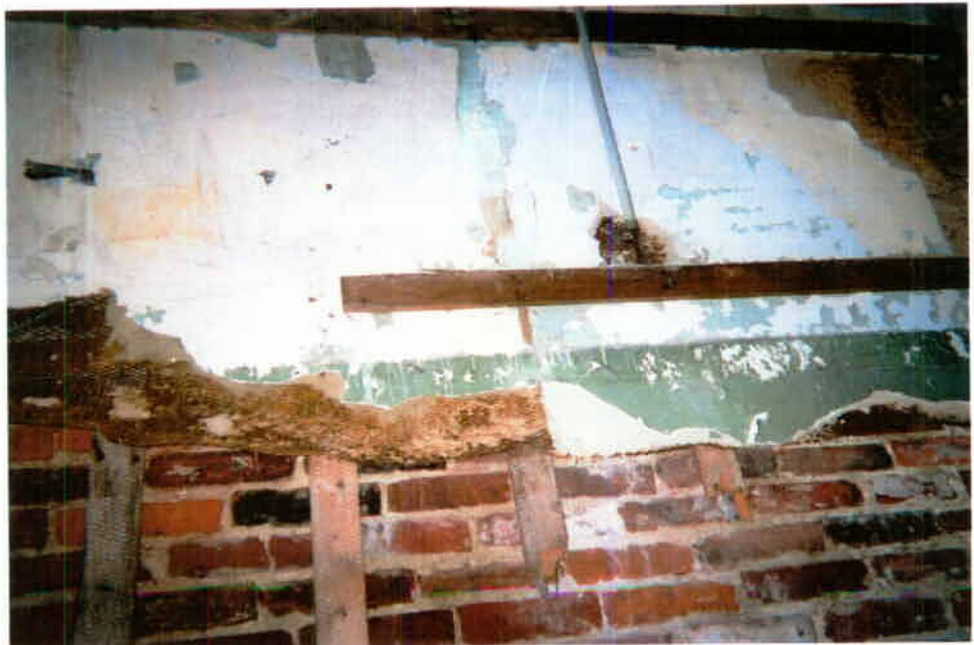
Photograph 8

Orientation: Photograph taken standing at the center of the warehouse towards the west.

Description: Deteriorating western wall might be plastered with asbestos-containing material. Wall plaster samples LA/WP-03 and 04 were collected from this area.

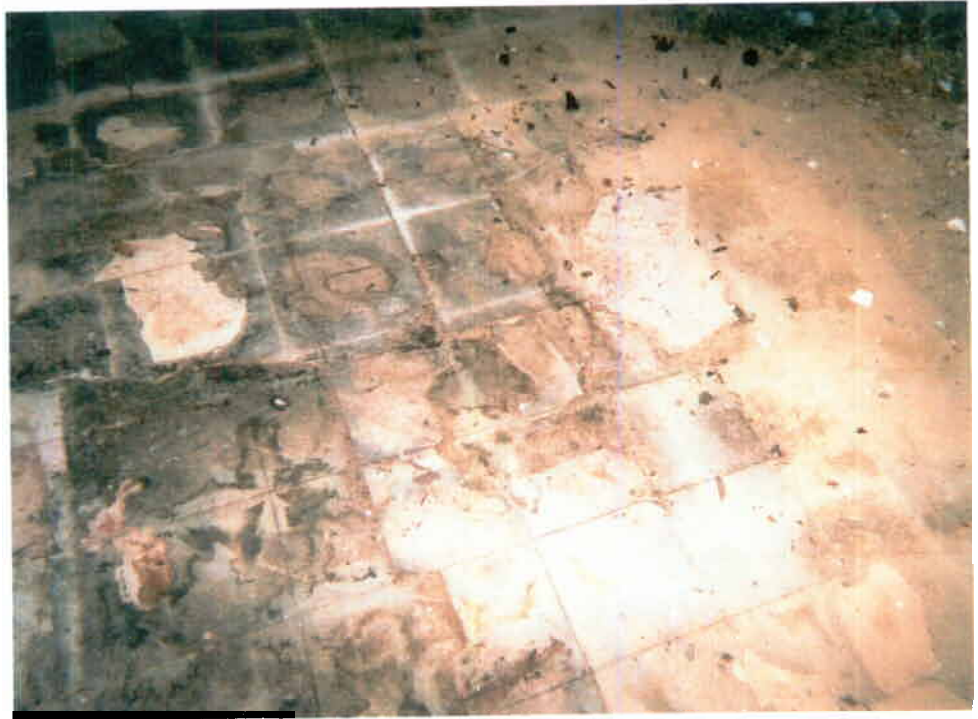
Orientation: Photograph taken standing at the center of the warehouse towards west.

Description: Floor tiles might be made of asbestos-containing materials.

Tetra Tech recommends that the floor tiles and roofing materials should be removed, with proper personal protective equipment and properly disposed before any work starts on site.

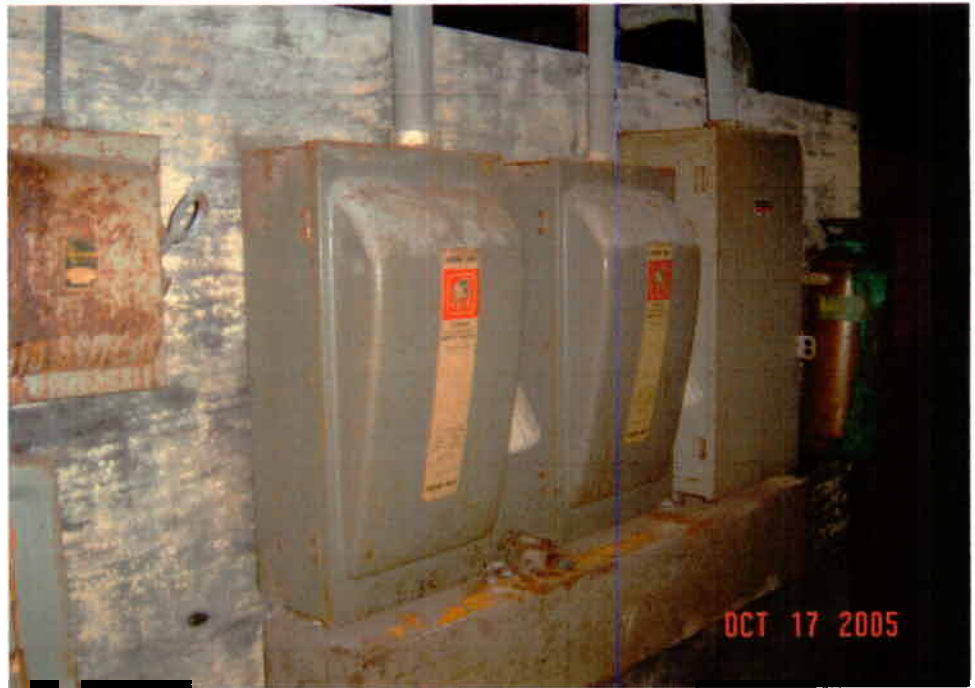
Orientation: Photograph taken in the basement.

Description: Electrical panel placed on the wall inside the cage marked as transformer area. One soil sample LA/SS-08 was collected from beneath the panel.

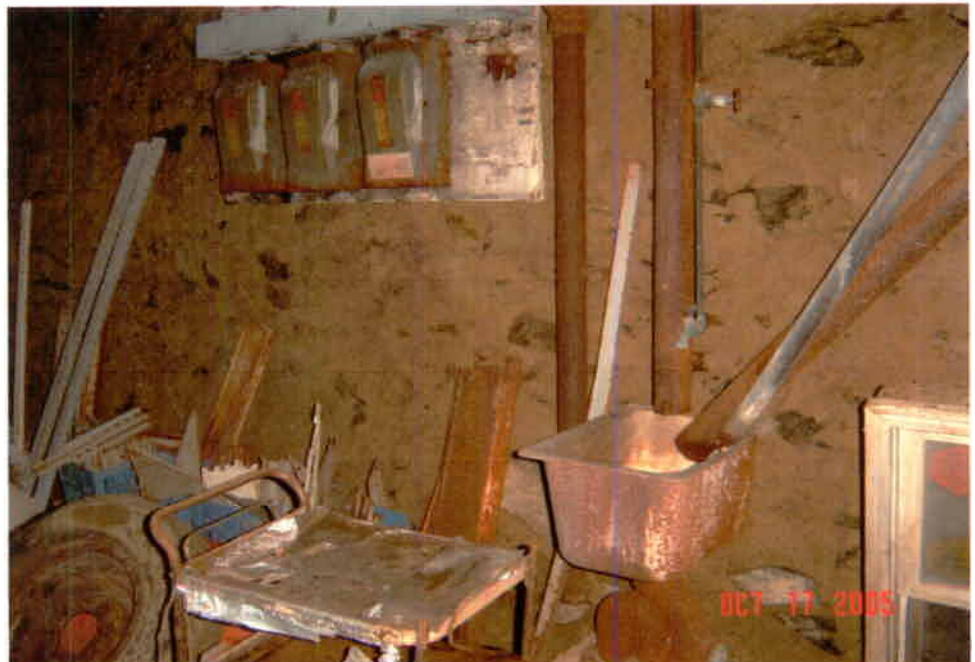
Photograph 12

Orientation: Basement right wall (looking from the entrance stair case).

Description: Debris of various kinds (wash basin, tire, wood and steel pieces, etc.) are located along the right wall of the basement.

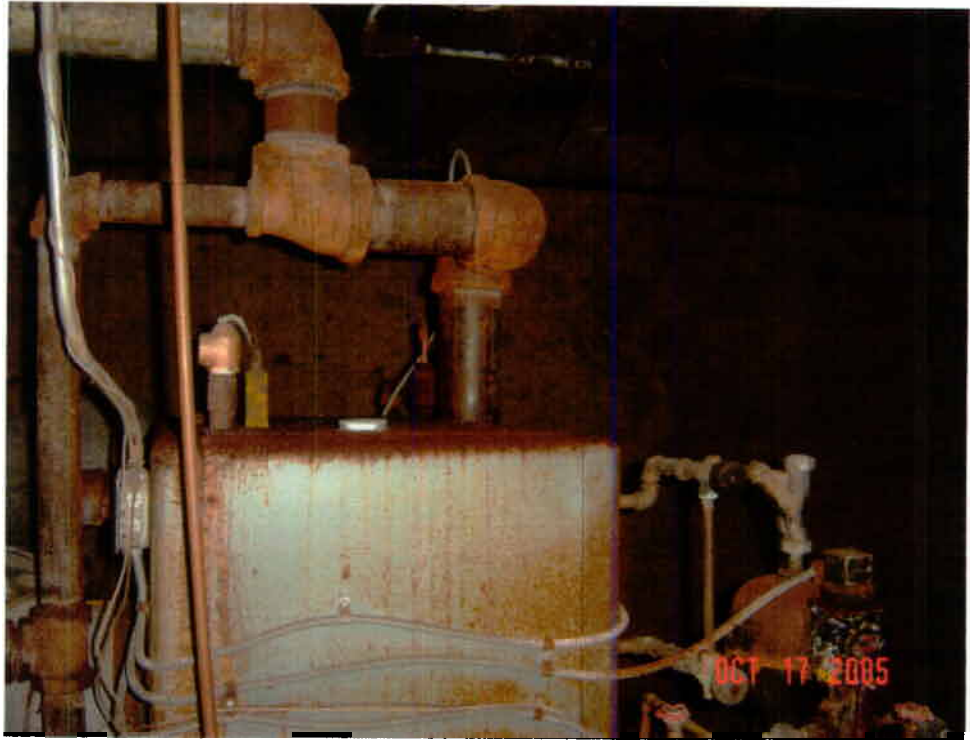
Orientation: Photograph taken in the basement

Description: One old gas heater is located at the far end of the basement (opposite to the entrance) along the right wall. Sample LA/SS-04 was collected in front of the heater.

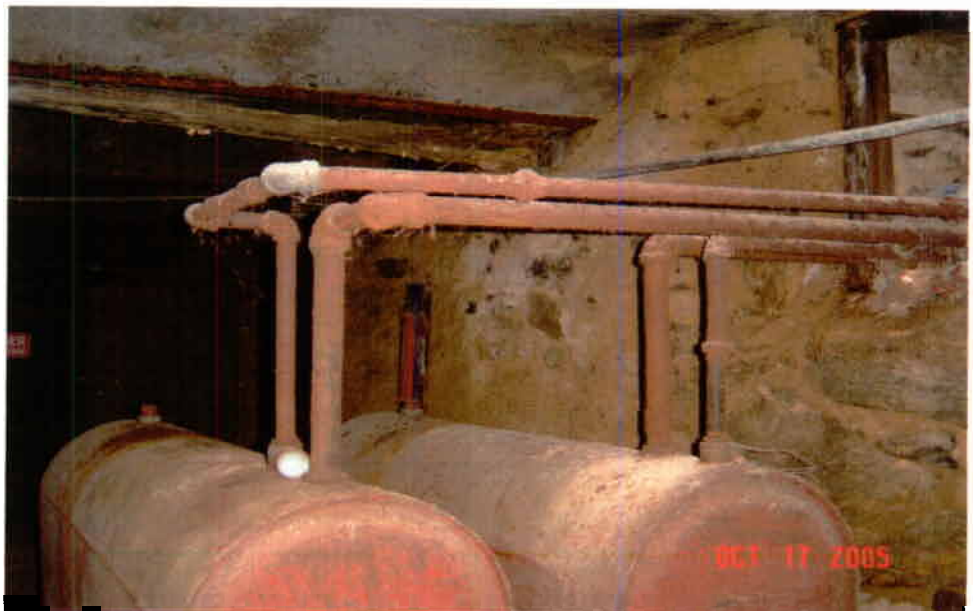
Photograph 14

Orientation: Basement left wall (looking from the entrance stair case)

Description:

Two aboveground storage tanks are located along the left wall of the basement. Samples LA/SS-02 and 03 were collected from this area.

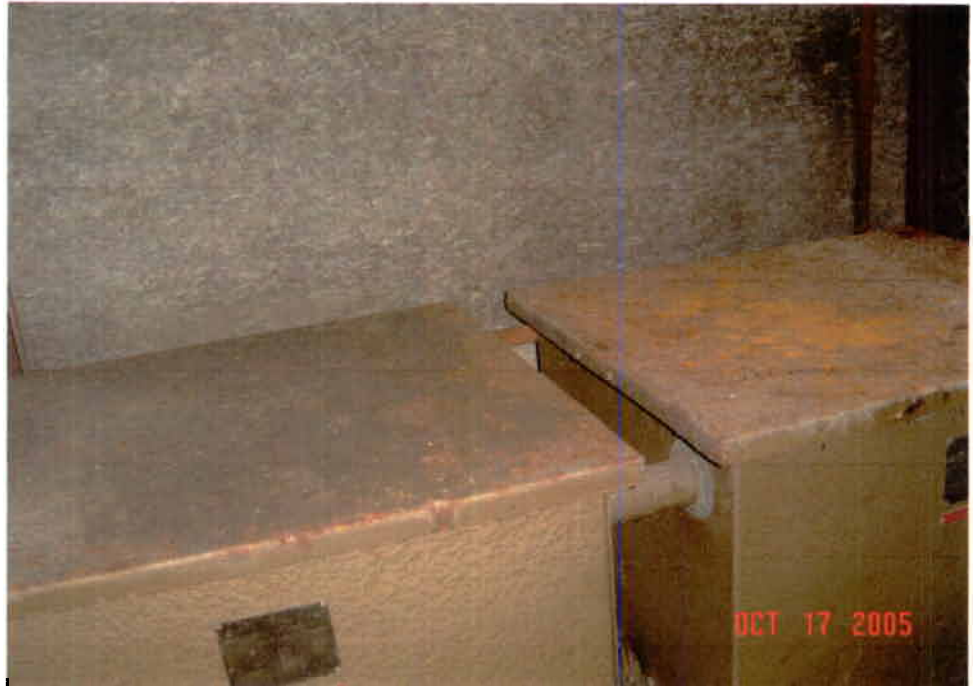
Orientation: Photograph taken in the basement inside the fenced area.

Description: Three transformers were located in a fenced area at the basement (only two are visible in the photograph). The fenced area is shown in Photograph 6. Samples LA/05, 06, and 07 were collected from this area.

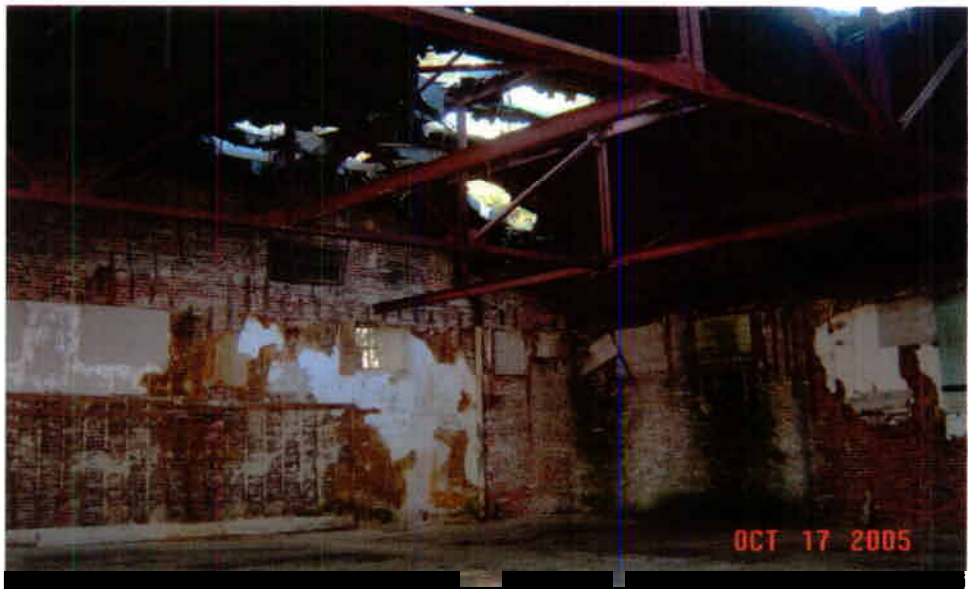
Photograph 16

Orientation: Northwest corner of the warehouse from the main entrance.

Description:

Roof trusses are in good shape but the roof and the walls have deteriorated considerably.

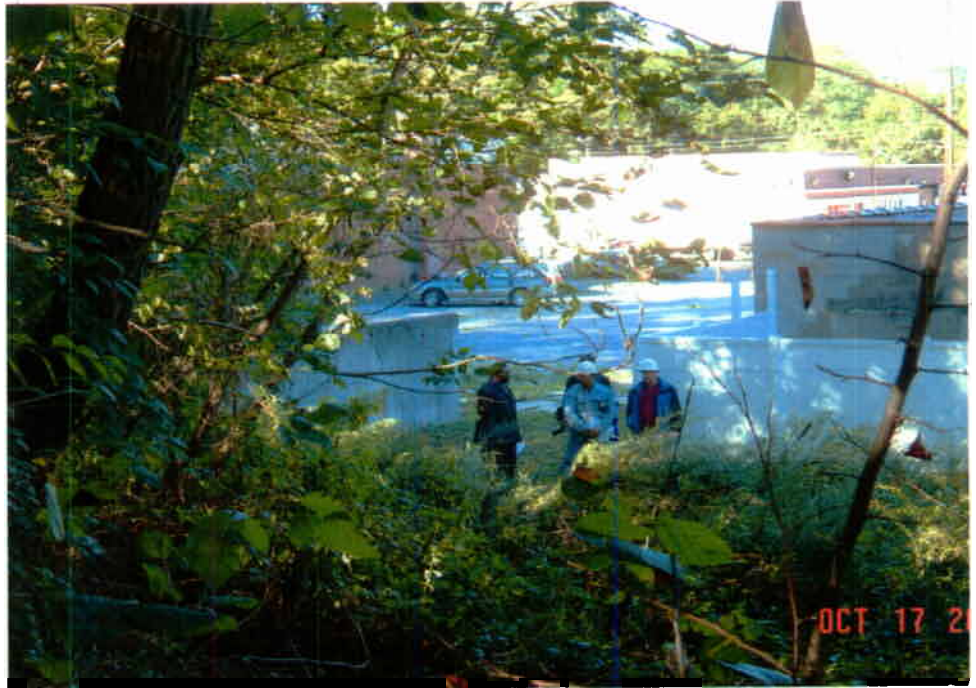
Orientation: Photograph taken from the wooded area on the hill located on the south of the site.

Description: Entire parking lot is visible from top of the hill. The hill area is approximately 15 feet above the parking lot.

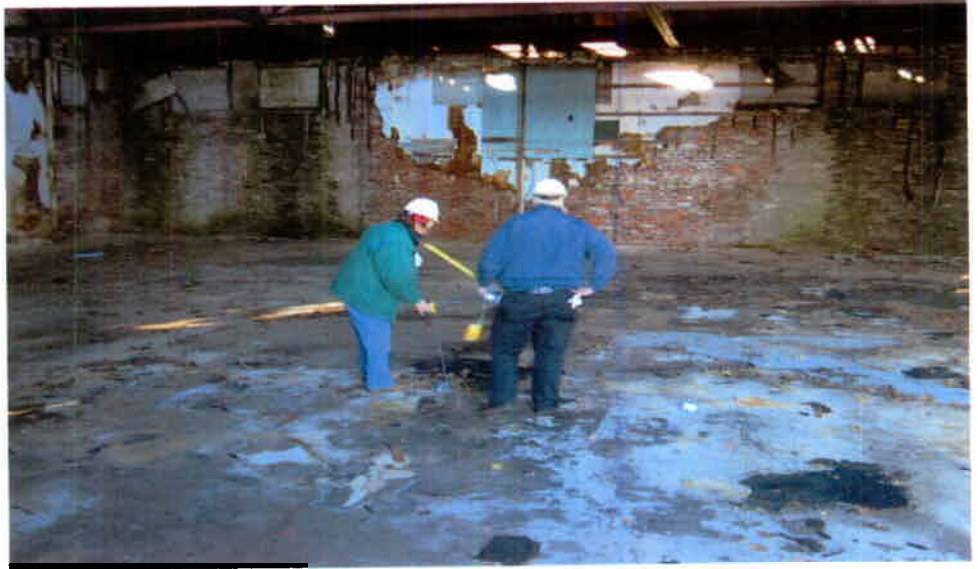
Orientation: Photograph taken inside the warehouse.

Description: Marian Murphy and Jim Kilpatrick from Tetra Tech are collected samples from the floor tiles.

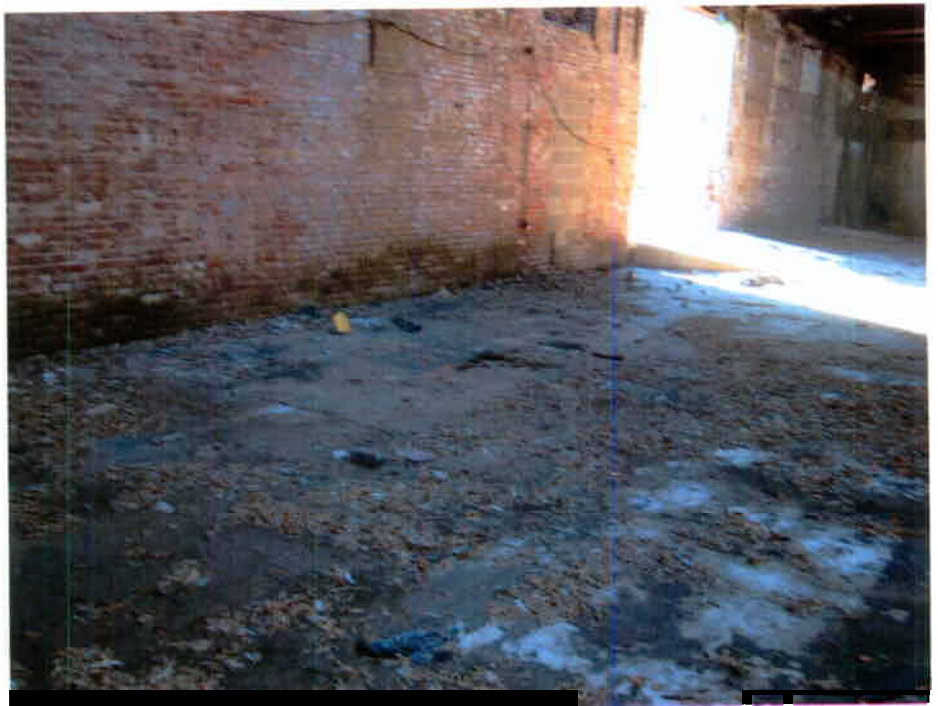
Photograph 6

Orientation: Photograph taken inside the warehouse.

Description:

General view of the warehouse. Walls are in deteriorated condition.

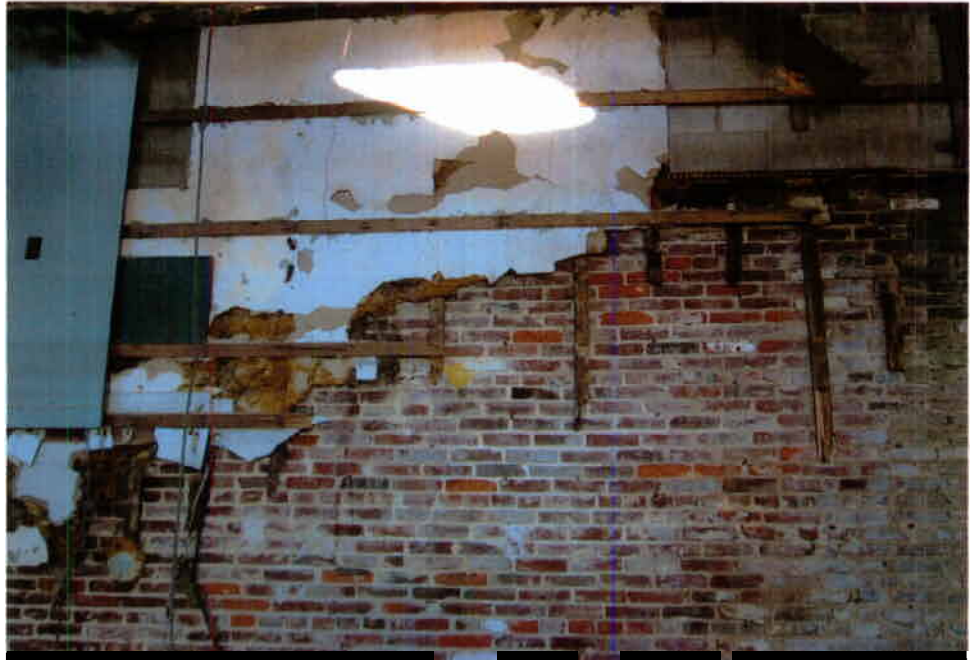
Orientation: Photograph taken inside the warehouse looking at the west wall.

Description: Samples were collected from the wall plaster for asbestos-containing material (ACM) analysis.

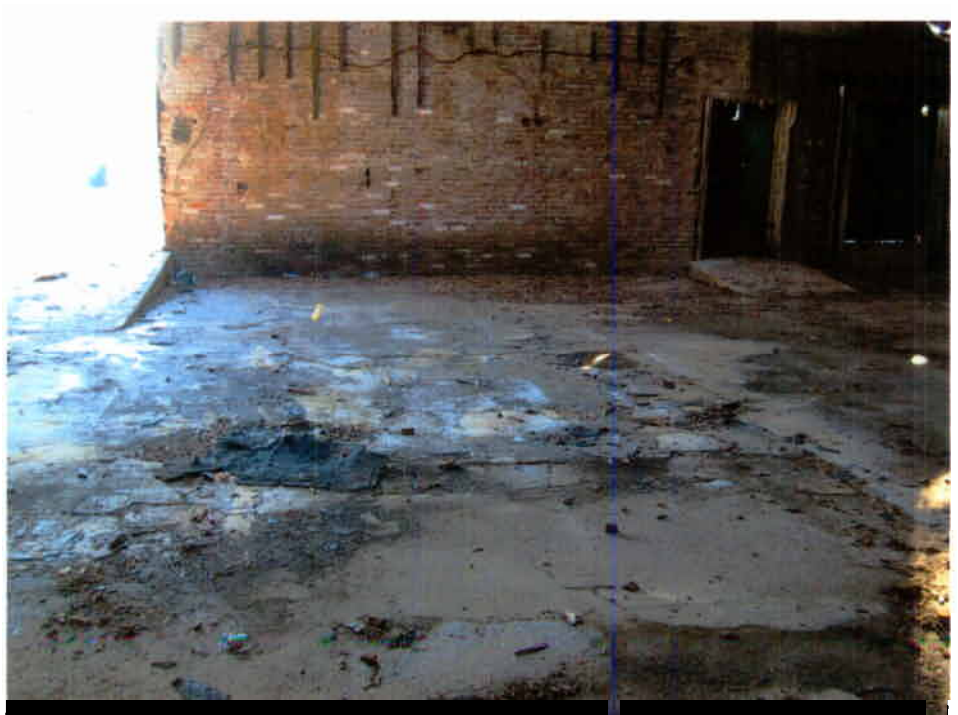
Photograph 8

Orientation: Photograph taken inside the warehouse.

Description:

Samples were collected from roofing material which was loosely lying on the floor for ACM analysis.

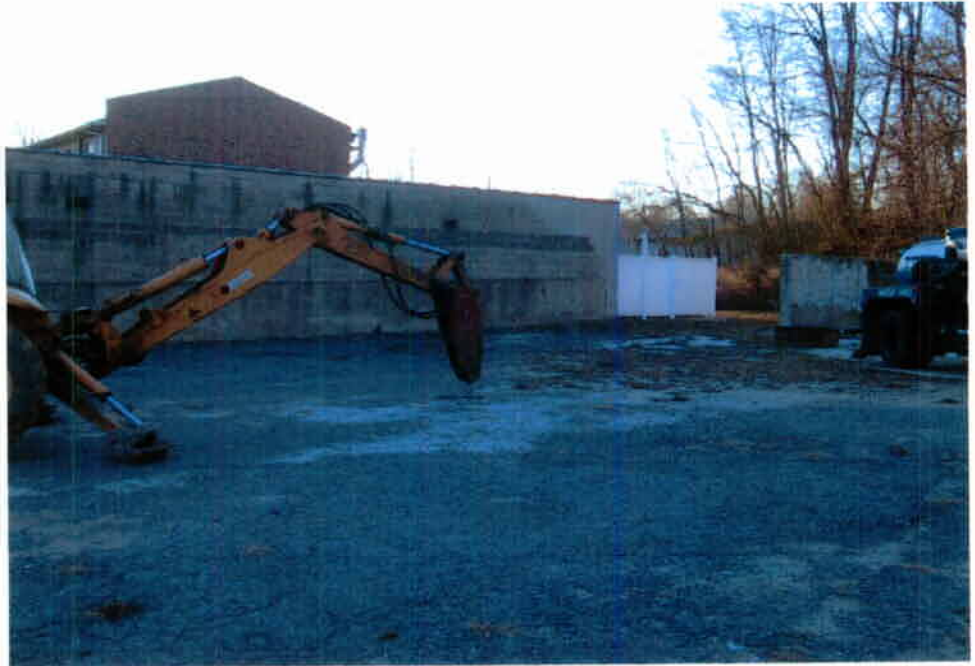
Orientation: Photograph taken in the parking lot.

Description: One backhoe, attached with a jack hammer, was used to break the concrete from the parking lot.

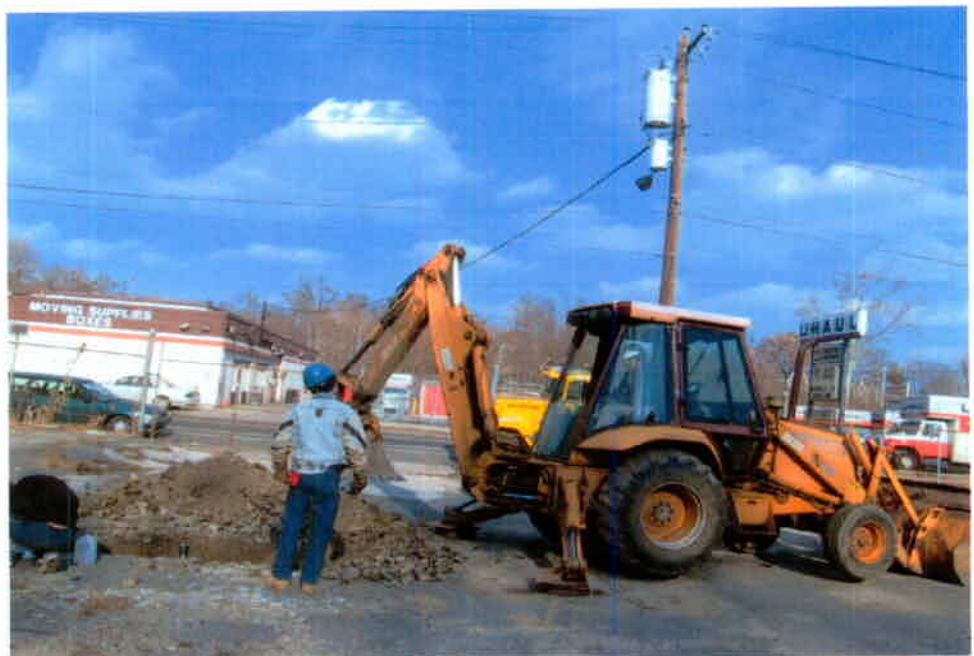
Photograph 10

One backhoe was used to excavate the infiltration pit number 5, located in front of the warehouse. U-Haul is visible just other side of Lancaster Avenue.

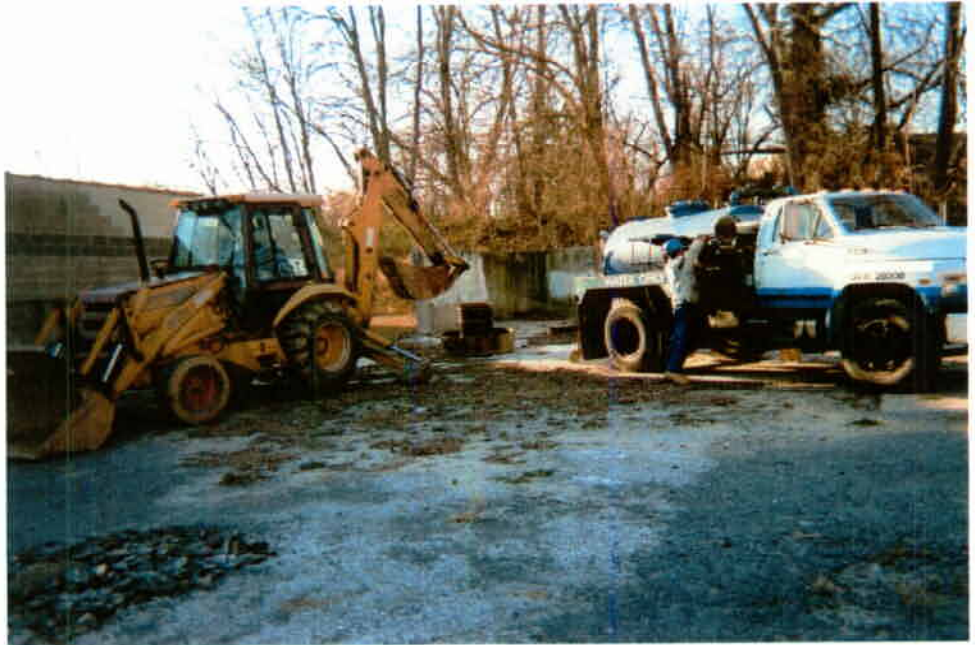
Orientation: Photograph taken in the parking lot.

Description: Backhoe bucket being decontaminated with water jet.

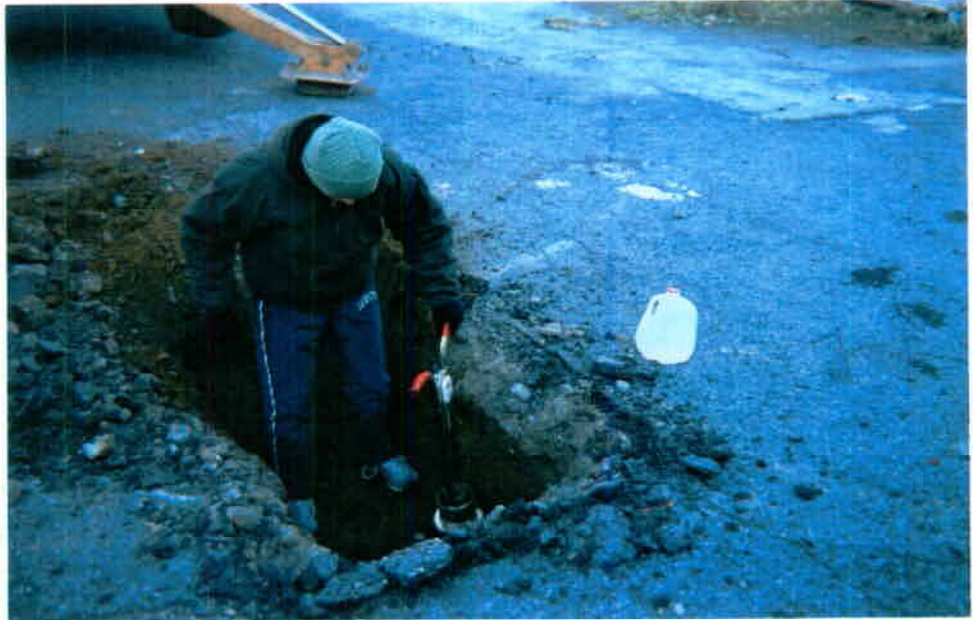
Photograph 12

Orientation: Photograph taken in the parking lot looking down an infiltration pit.

One backhoe excavated the pit and personnel from F.X. Browne is performing the infiltration test.

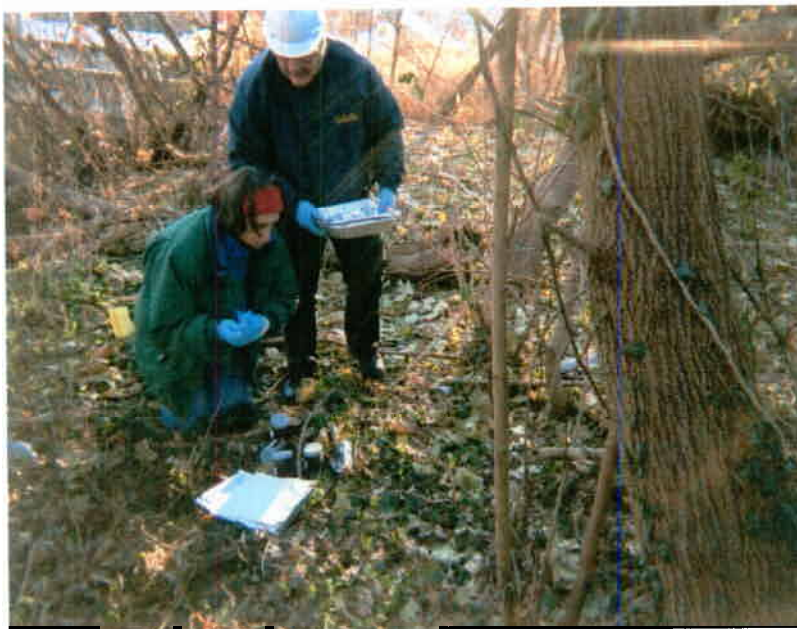
Orientation: Photograph taken looking southwest from the parking lot.

Description: Marian Murphy and Jim Kilpatrick from Tetra Tech are collecting soil sample from the wooded area located along the southern boundary of the site.

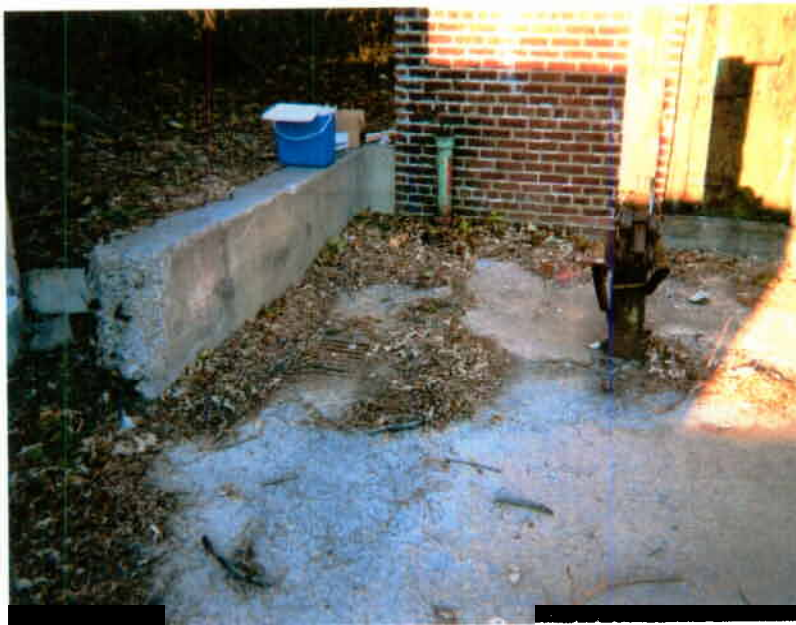
Photograph 14

Orientation: Photograph taken in the parking lot looking southwest.

Description:

One hand pump and the storm grate (covered by leaves) are visible. Sample LA/SS-17 was collected from beneath the storm grate.
